**Assessment on the Development and Coastal Erosion along the Middle Coastline of
Terengganu**

Dissertation submitted in partial fulfillment of
the requirements for the
Bachelor of Engineering (Hons)
(Civil Engineering)

JULY 2009

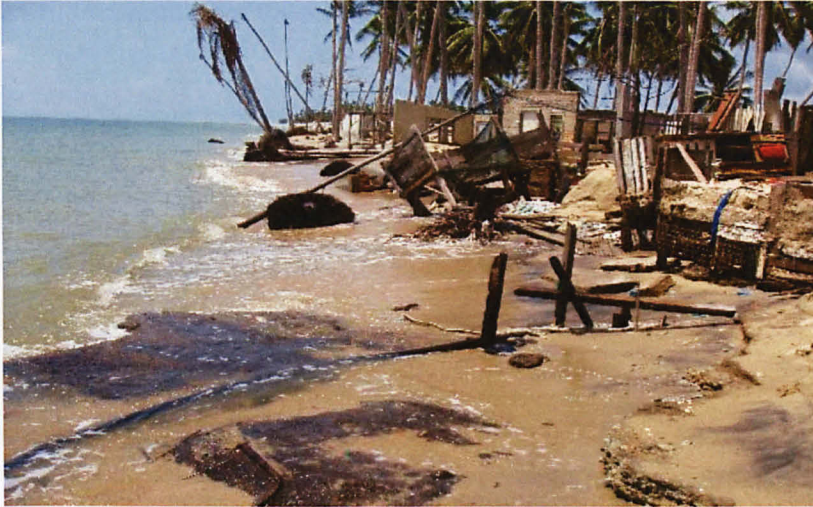
- Category 1: Shorelines currently in a state of erosion and where shore-based facilities or infrastructure are in immediate danger collapse or damage.
- Category 2: Shoreline eroding at a rate whereby public property and agriculture land of value will become threatened within 5 to 10 years unless remedial action is taken;

Figure 1.2: Coastal Erosion Category 1, source: <http://www.water.gov.my/>

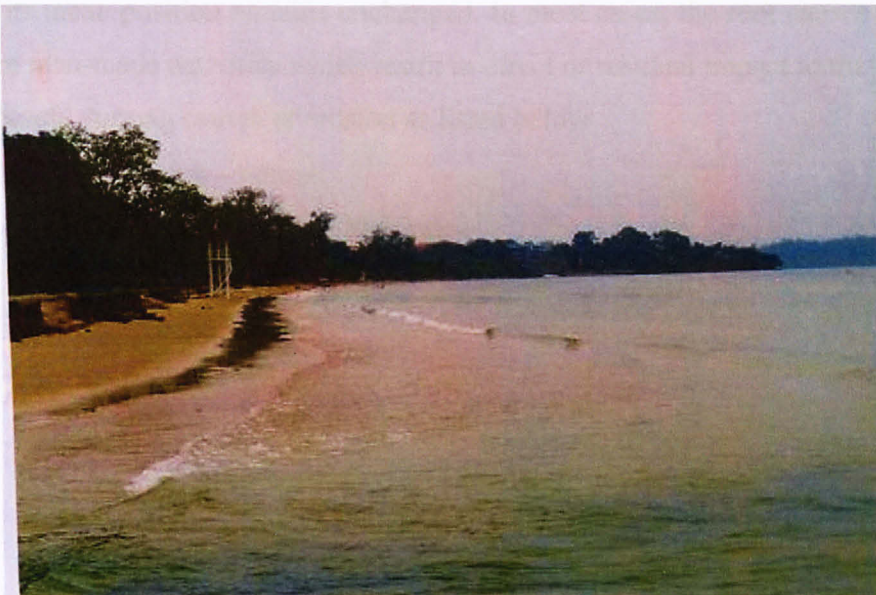
Figure 1.3: Coastal Erosion Category 2, source: <http://www.water.gov.my/>

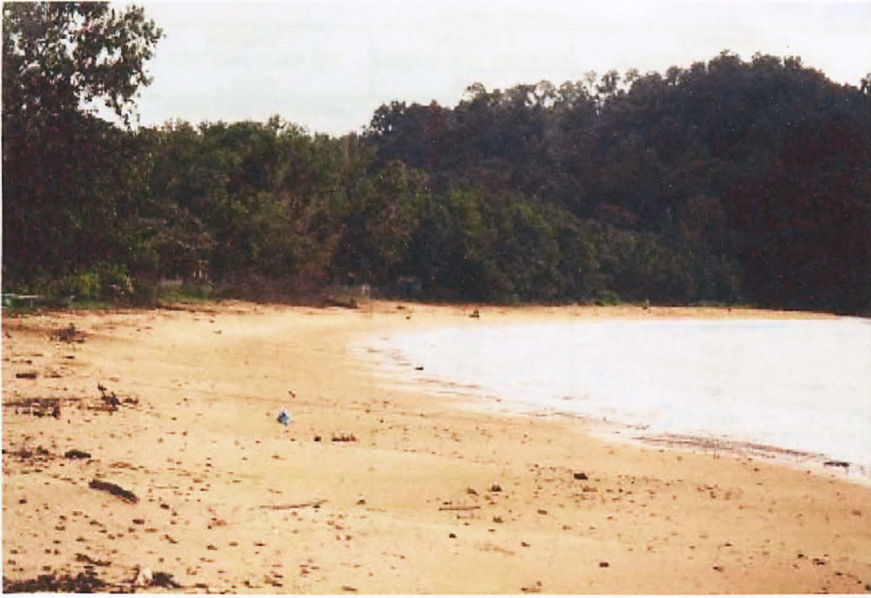
Category 3: Undeveloped shoreline experiencing erosion but with no or minor consequent economic loss if left unchecked.

Figure 1.4: Coastal Erosion Category 3, source: <http://www.water.gov.my/>

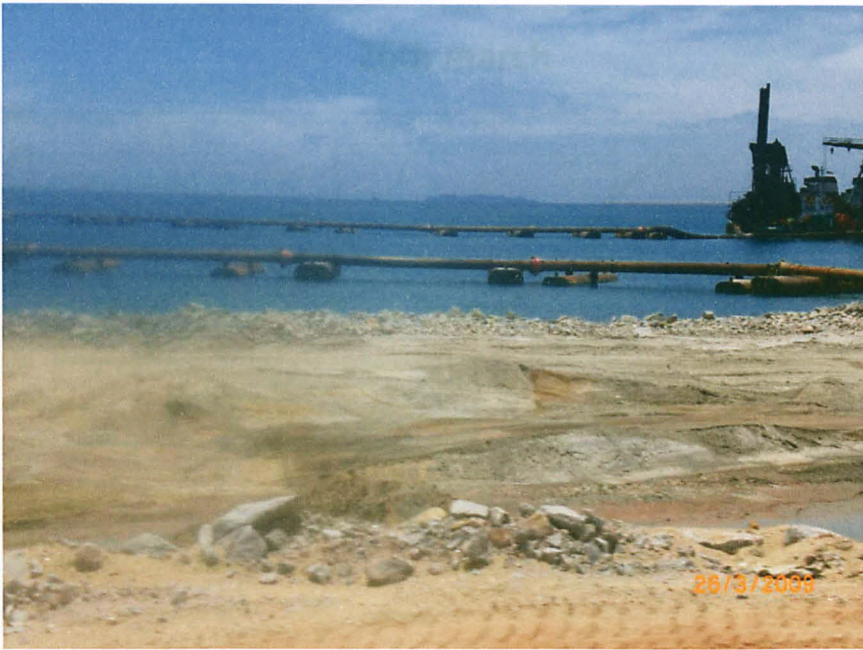
Figure 4.5: Heavily under construction near Teluk Ketapang Airport

During the site visit to the Teluk Ketapang, the project is still on-going project. I have opportunity to meet the Project Manager, En Wan Mohd Kipin Wan Mohdun to tell briefly about the project. According to him, this area between Teluk Ketapang and Batu Puteh, the coastal is categorized as Category 1 which is very critical. The erosion is caused by the northern exposure but the southern side stabilized back the beach area. Thus the local authority is decided to construct the coastal erosion control in this area.
